# Intel® Celeron® M Processor

Specification Update

*September 2006*

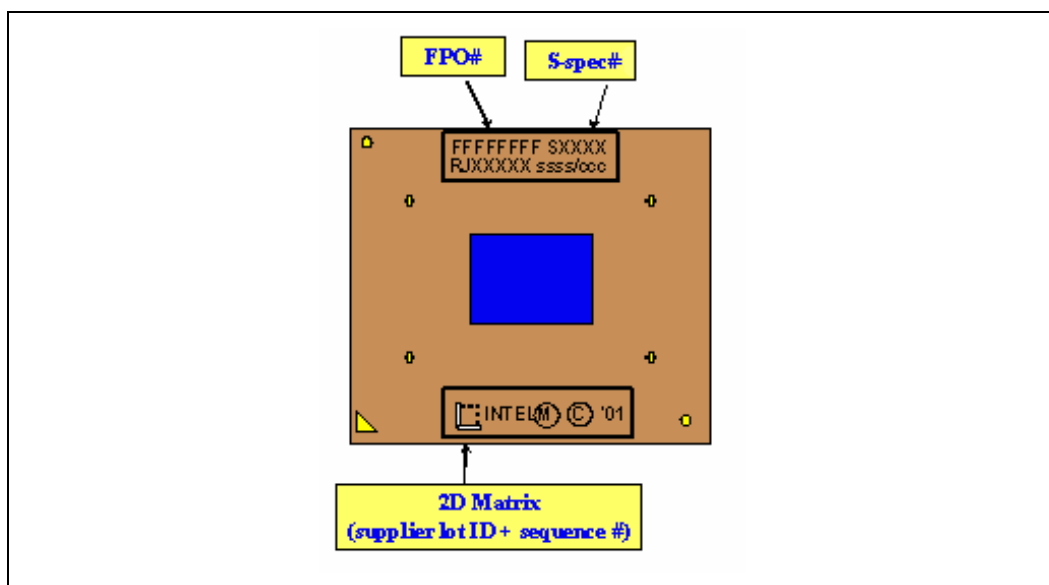
Figure 1. Intel Celeron M Processor (Micro-FCPGA/FCBGA) S-Spec Markings

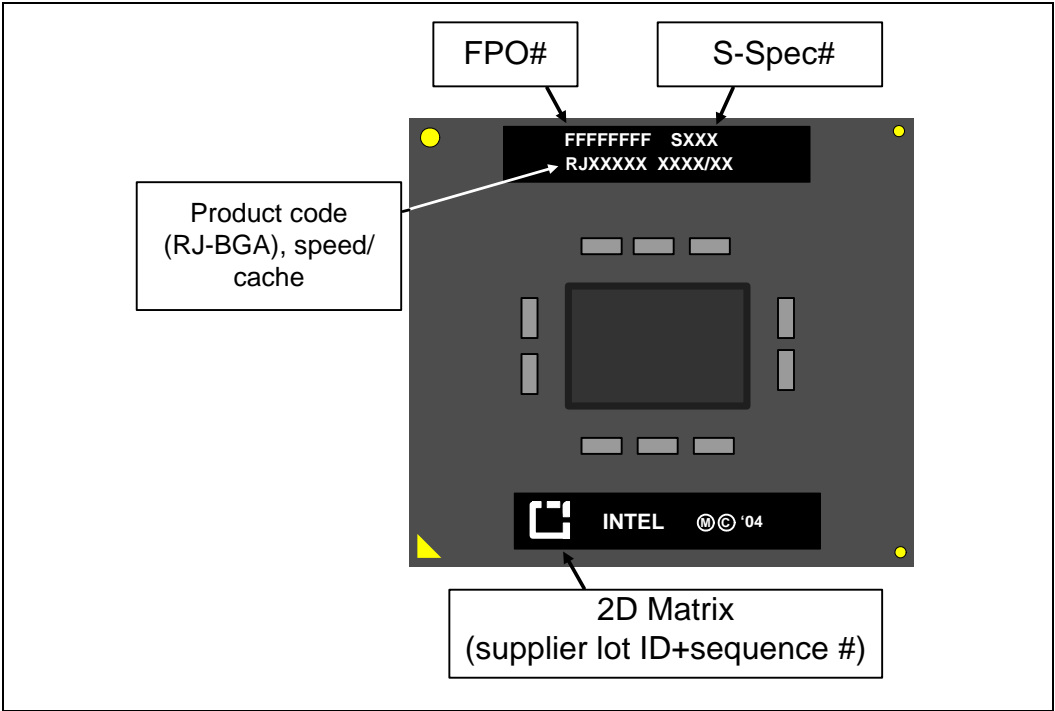
Figure 2. Intel Celeron Processor ULV on 90 nm Process (Micro-FCBGA) S-Spec Markings

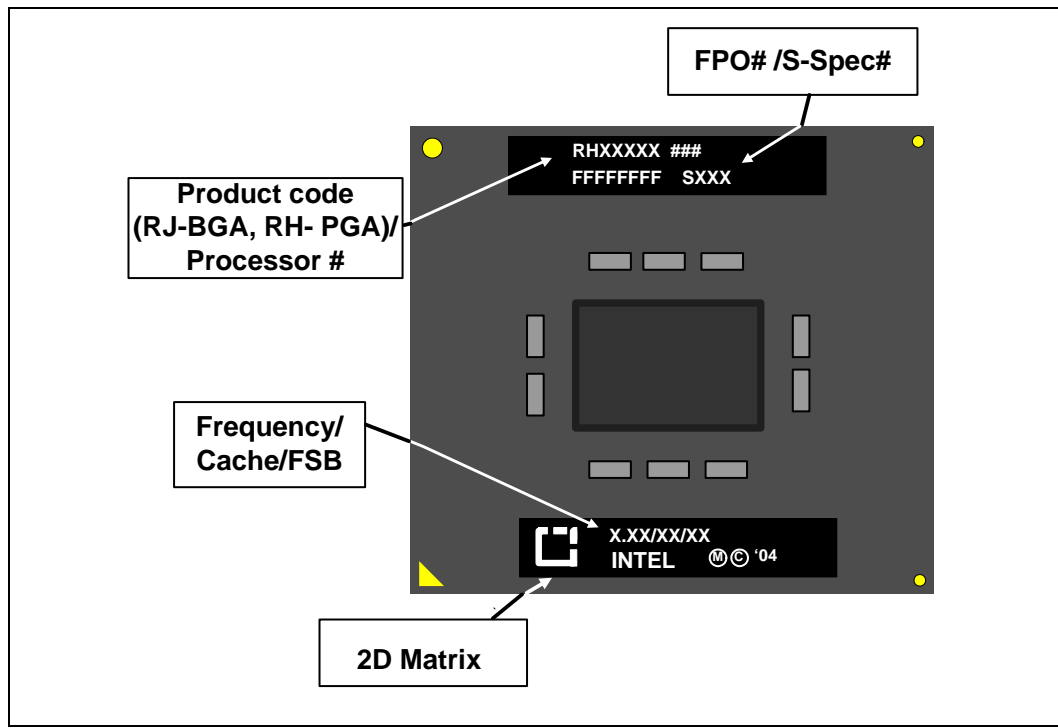
Figure 3. Intel Celeron M Processor on 90 nm Process (Micro-FCPGA/FCBGA) S-Spec Markings

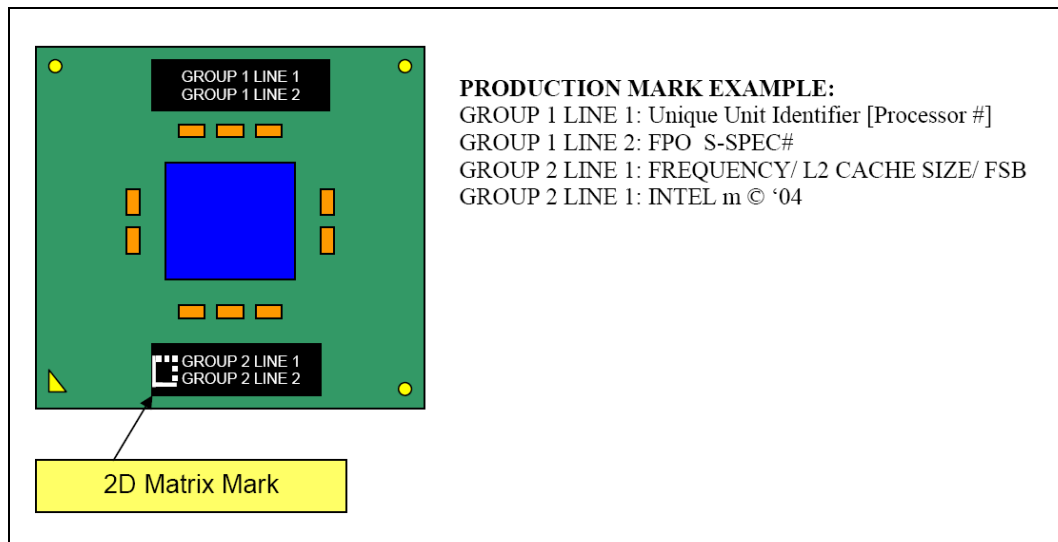
Figure 4. Intel Celeron M Processor on 65 nm Process (Micro-FCPGA/FCBGA) S-Spec Markings

-020	<ul style="list-style-type: none"> <li>Updated Errata information as indicated in the Summary Tables of Changes</li> <li>Updated Processor Identification Table 1</li> <li>Added Figure 4</li> </ul>	May 2006
